# **INDOOR AIR QUALITY ASSESSMENT**

**Helen R. Donaghue Elementary School  
24 Union Street Extension  
Merrimac, Massachusetts**

Prepared by:  
Massachusetts Department of Public Health  
Bureau of Environmental Health Assessment  
Emergency Response/Indoor Air Quality Program  
August 2003

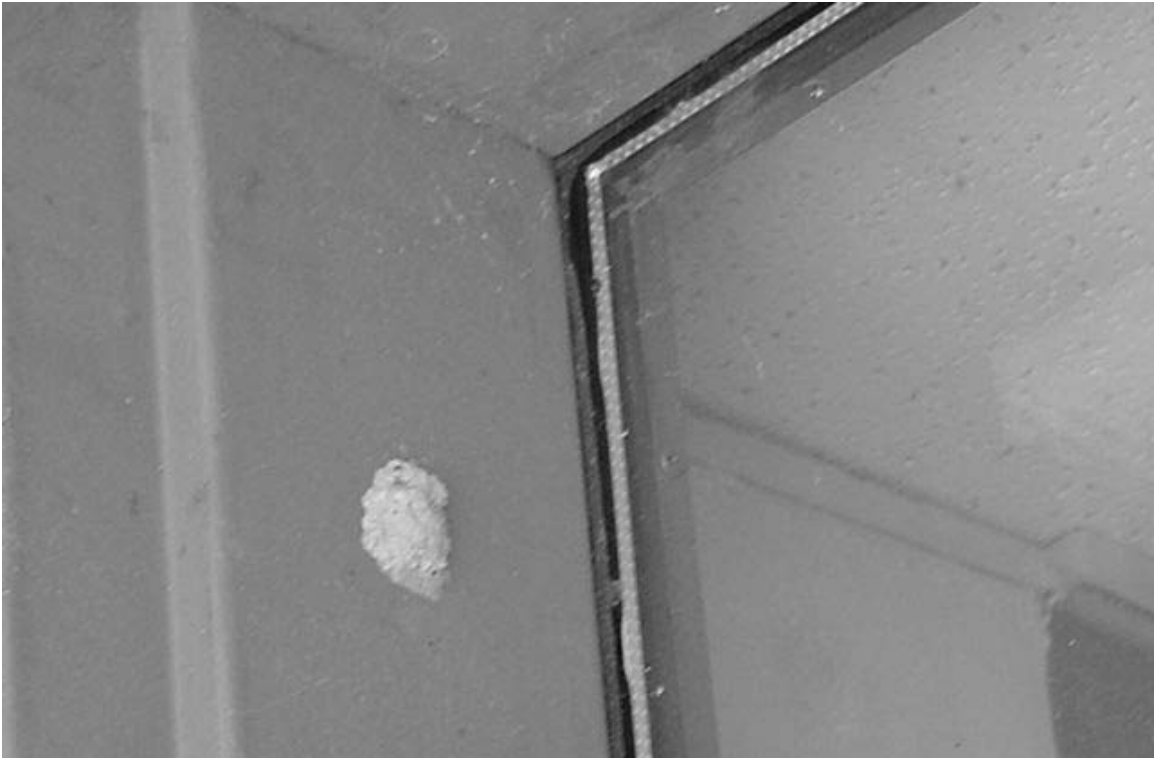
**Picture 24**

Finally, during the perimeter examination of the building, a wasps' nest was observed along the exterior wall (Picture 24). To prevent potential problems, these nests should be removed in a manner so as to prevent the use of pesticides and/or prevent insect movement into the building.

**Nest on exterior of window frame**

16. Seal all utility holes, wall cracks and any other possible pathways to prevent the egress of materials into the school.
17. Remove wasp's nests from perimeter of the building in a manner as to not introduce insects and/or pesticides into the building.
